**FREBYRD HOME INSPECTIONS**  
**VIRGINIA BEACH, VA.**  
**BUS/FAX : 757-204-4527**  
**CELL: 757-407-1327**

Some Where In Hampton Roads Area.  
Street \_\_\_\_\_

JOHN BYRD (VA. STATE HOME INSPECTOR CERTIFICATION NUMBER 3380-000336 EXP 01-31-2012)

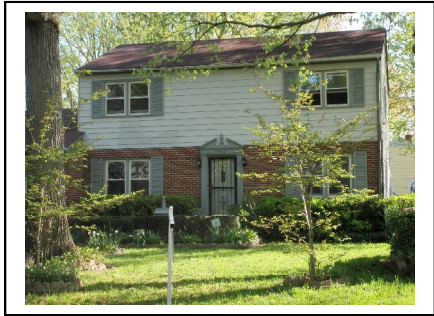
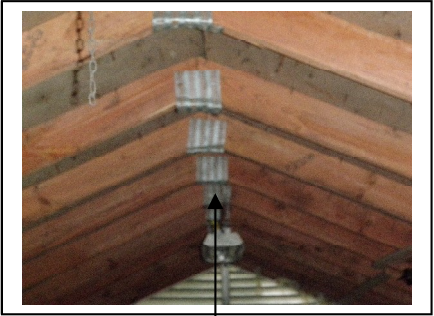
N/p--All Trusses & chords in Attic Have been cut or removed about 16 total causing vertical& Lateral loads to drift ( Recommend a License structure Engineer evaluate and repair as needed )

Various Trusses Damage and chords are missing in attic

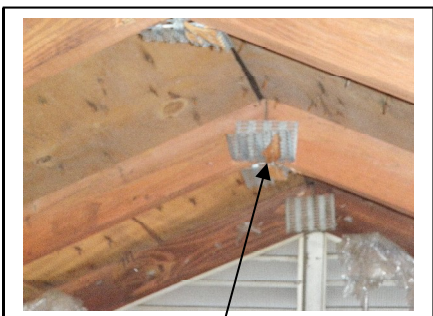
--All Trusses in Attic Have been cut about 16 total causing vertical& Lateral loads to drift (Recommend a License Structure Engineer evaluate and repair as needed )

More damage Trusses in Attic about a total of 16

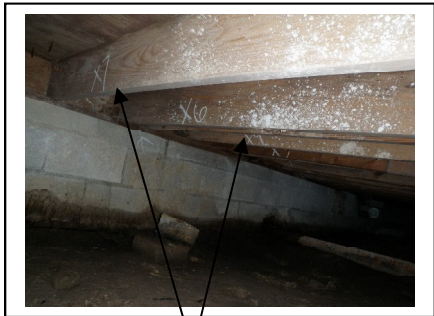
G--Evidence of past termite damage to subfloor framing at front of home in crawl space about 8 2x10 Damage ( Recommend a License Termite inspection and a license Structure engineer/ structure contractor evaluate all framing in crawl space and repair as needed )

Various Termite damage to Floor framing in crawl space at front of home

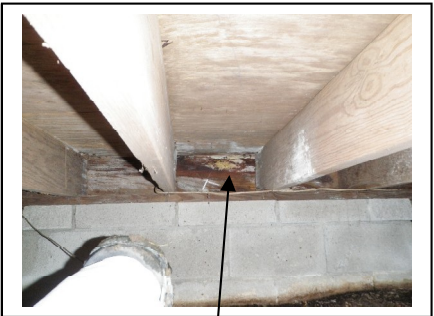
g--Moisture Damage to Band board and sill plate at rear porch area ( Recommend a license Structure contractor evaluate and repair as needed )

Moisture damage to rear Band board and sill plate at rear door under porch in crawl space

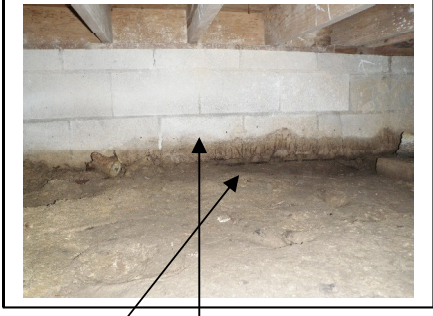
A/B --Cracks at front right Foundation block area with soil subsiding under foundation blocks and possible footing area ( Recommend a license Structure engineer evaluate and repair as needed )

Cracked House foundation with soil subsiding under foundation blocks

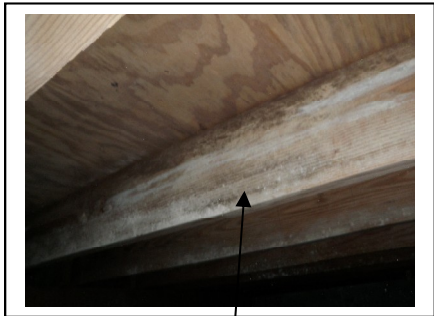
a--Mold, mildew, fungus formations on subfloor framing (Recommend a moisture control contractor evaluate and repair as needed )

Mold and fungus like formations on subflooring in crawl space

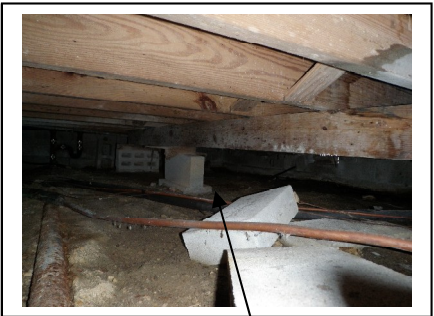
F--Temporary Columns under kitchen floor have been installed (Recommend a license Structure contractor evaluate and repair as needed )

Temporary columns under kitchen area in Crawl space

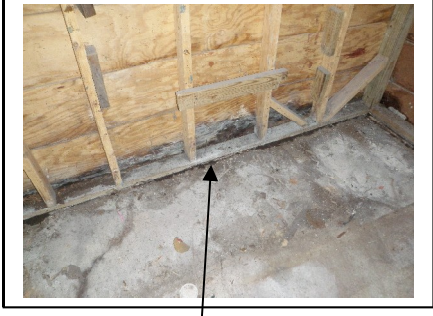
Moisture Damage to Sill plate and framing at detached garage

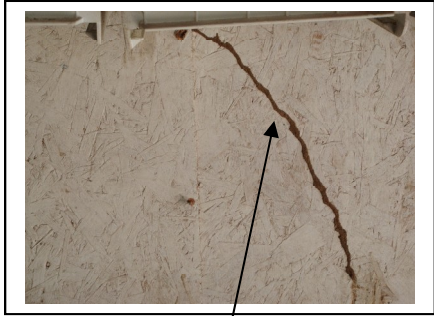
Termite Tubes In Detached garage

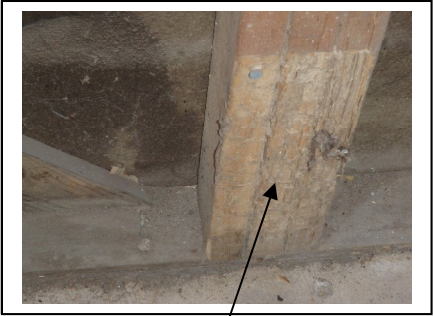
--Evidence of past termite damage to framing at Detached Garage ( Recommend a license Termite and Structure contractor evaluate and repair as needed )

Termite Damage to Structure members in detached Garage

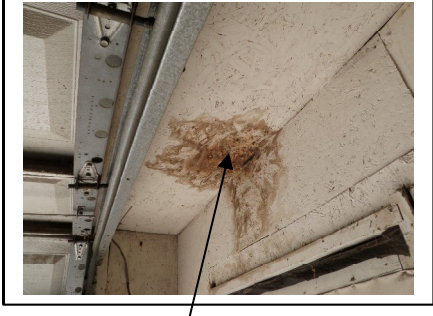
Moisture Stains in side Detached garage

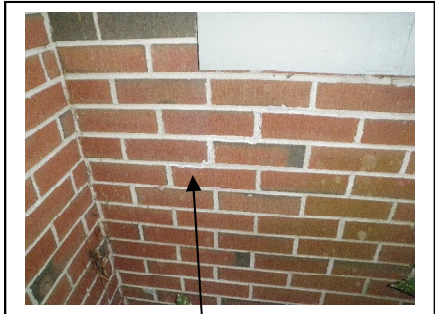
n--Brick veneer at front of home has cracked ( Recommend a license structure/Masonry evaluate and repair as needed )

Cracks at brick veneer at front of home

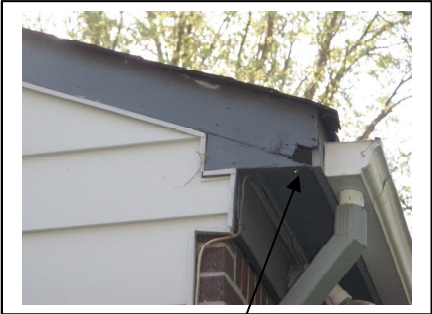
More damage to trim and facial boards

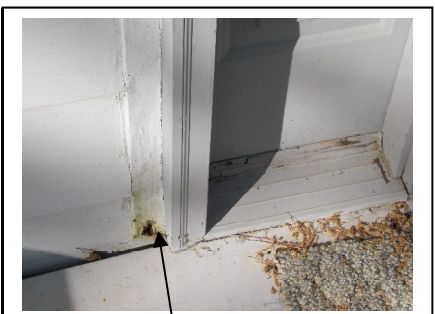
More Moisture damage

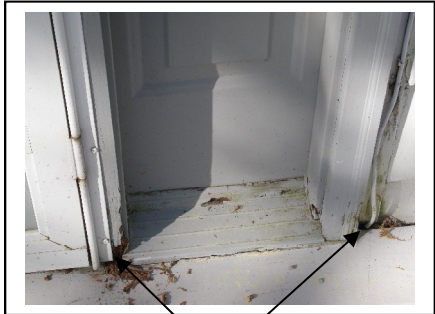
--Moisture damage to trim around rear and front doors

Moisture damage to trim around front door

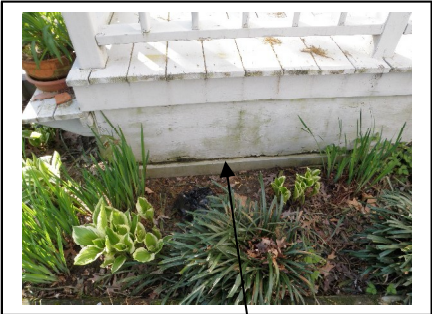
--Moisture damage to skirting around rear porch (Recommend repairing all damage wood )

Moisture damage to skirting around rear porch

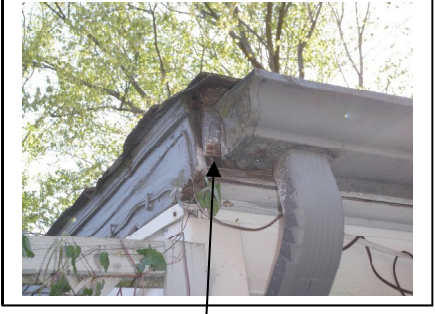
Moisture damage to trim

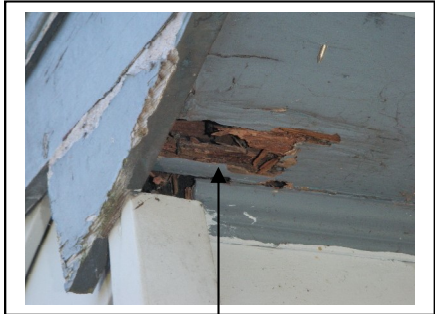
--Moisture/rot damage to trim and facial boards and soffits at Detached Garages ( Recommend evaluate and repair )

Moisture damage to Exterior trim and soffit at home and detached garage and other buildings

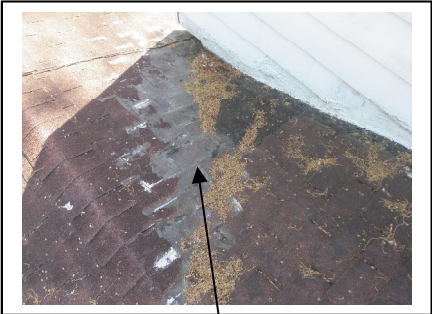
--Active Leak or at one time at valley on roof over sun room , It now has mastic applied to shingles and side of Home .( Recommend a license Roofer evaluate and repair as needed

Damage valley on roof that has at some time leaked to sun room

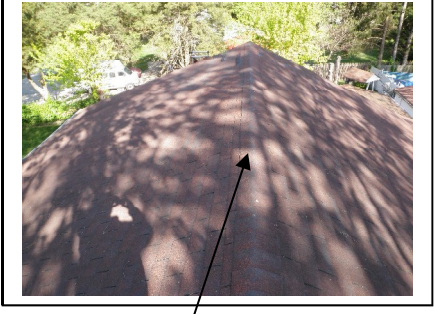
Age and damage roof shingles

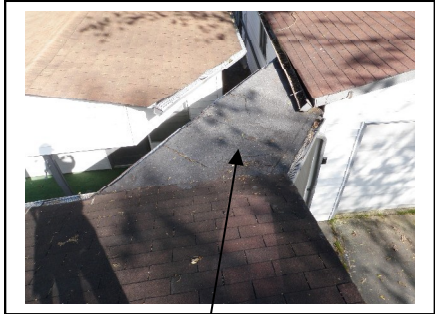
Damage Flat roof and damage to gutters

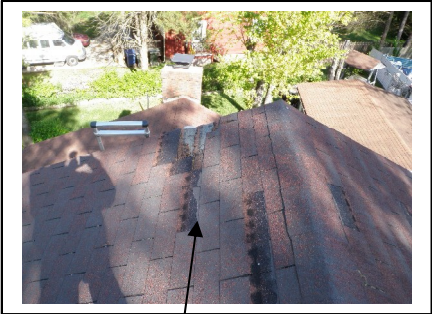
--Aged, deteriorated roof with missing and cracked shingle tabs at Home and at all detached garages (Recommend a license Roofer evaluate and repair as needed )

Aged And Deteriorated Roofs with missing and damage tabs.

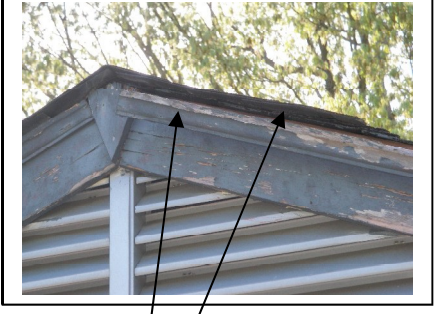
--Multiple layers of shingles on Roof all in bad shape (Recommend a License Roofer evaluate and repair as needed.)

Multiple Layers of shingles installed on roofs and loose trim

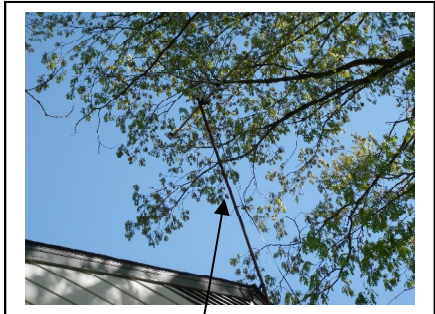
--TV Antenna is loose at right side of home at ridge area and is in danger of falling toward Electrical service cable (Recommend removing antenna from home )

Loose Old TV Antenna at ridge of roof

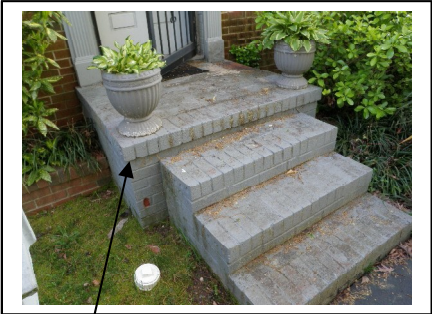
--Recommend installing rails at front porch.

Railing needed (upgrade )

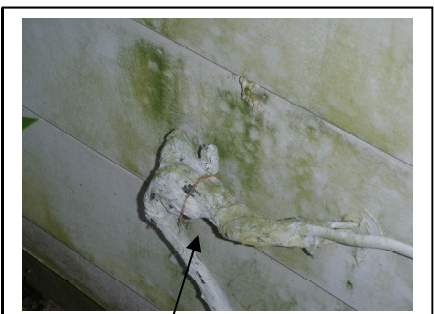
Spliced nwires/at left side of home

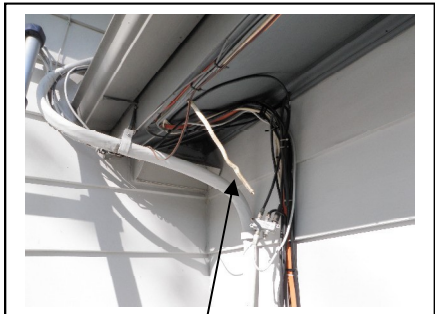
Loose Electrical wire at right side of sun room

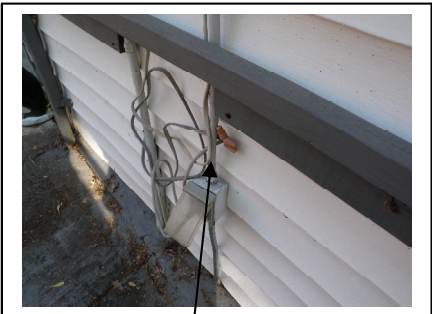
Splice wires at left side of detached garage

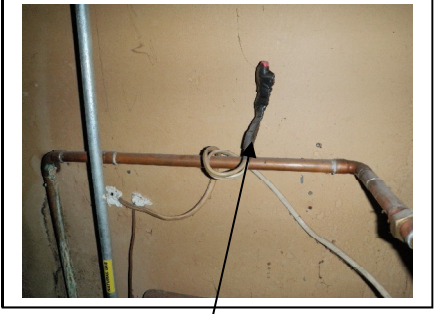
Splice electrical wire at hot water heater

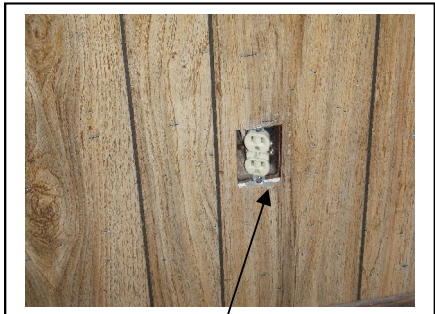
Various Covers missing

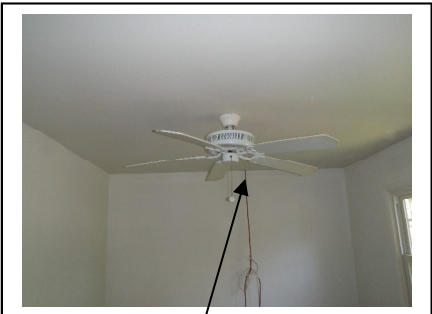
Various fan do not work

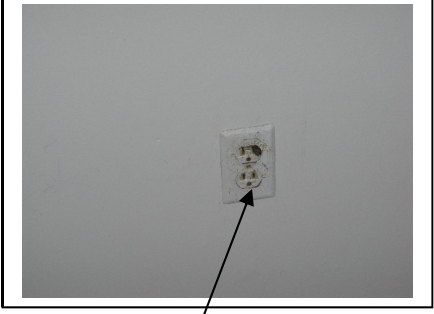
Various Broken crack Electrical outlets

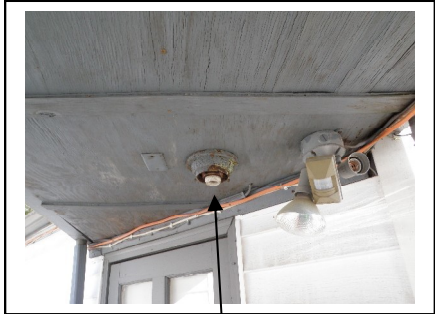
Open Light fixtures

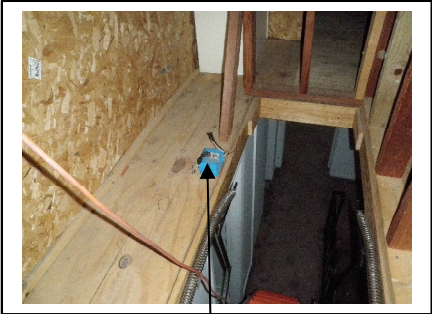
Open electrical box in attic

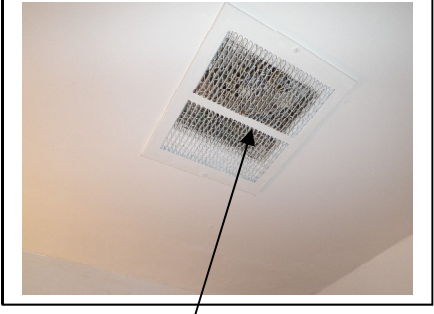
--Master bathroom exhaust fan is noisy ( Recommend replacing )

Noisy bath fan at master bathroom

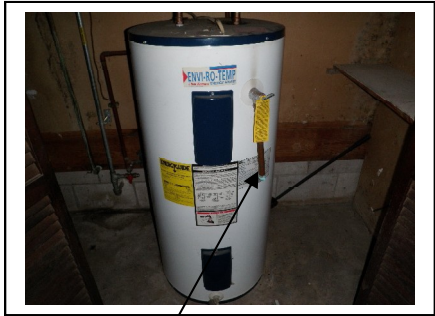
--Aged hot water heater and extension pipe not installed correctly (Recommend a license plumber evaluate and repair as needed )

Aged Hot water heater , No Pan , and TPR extension pipe is not correct

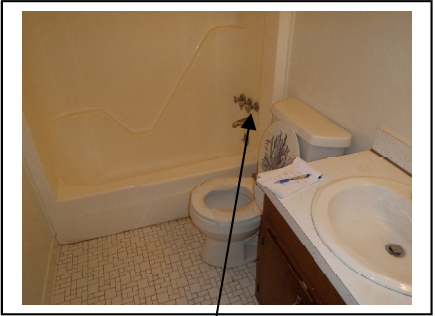
Plumbing fixtures that do work , hard to turn

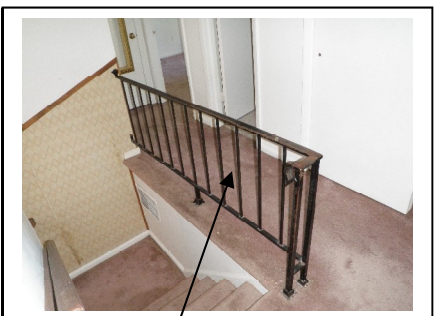
Loose railing at stairs

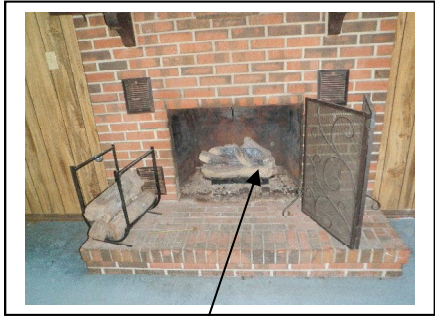
--Gas log fire place pilot not lit ( Recommend have lit and retest during final walk thur.)

Gas log fire place / not tested ((Recommend a license chimney sweep inspect and service )

--Recommend fireplace insert be inspected and clean by a license chimney sweep)

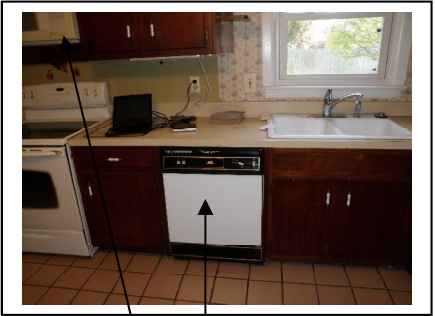
Dishwasher loose at counter top and aged Microwave

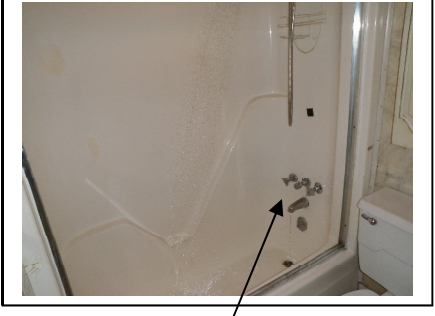
--Various Hardware at tubs and sinks need replacing hard to turn ( Recommend a license plumber evaluate all plumbing

Various Plumbing fixtures in home do not work hard to turn

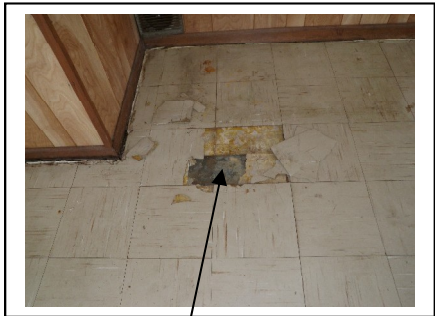
--Moisture damage to trim and flooring in sun room

Damage flooring in sun room

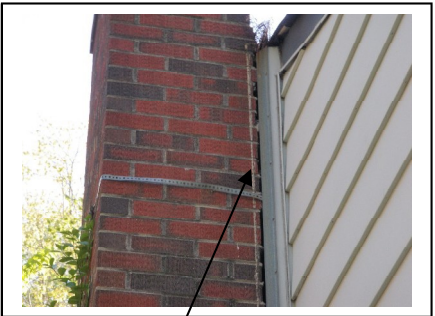
Chimney is pull away from home or vice versa

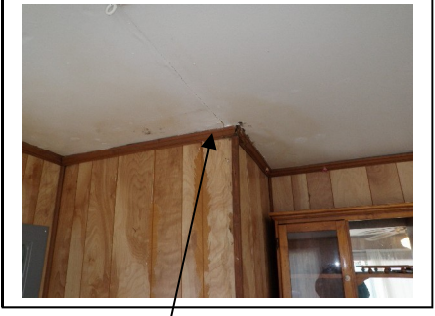
Stains in sunroom
